# Downtown Property Data

Property Number:	29	Property Owner:	Amshaan Investment
Property Address:	-	Primary Contact:	-
Mailing Address:	1132 Rayburn Dr 105 San Antonio	Phone Number:	-
Lease Price:	-	Sale Price:	-
Lease Terms:	-	Square Feet:	-

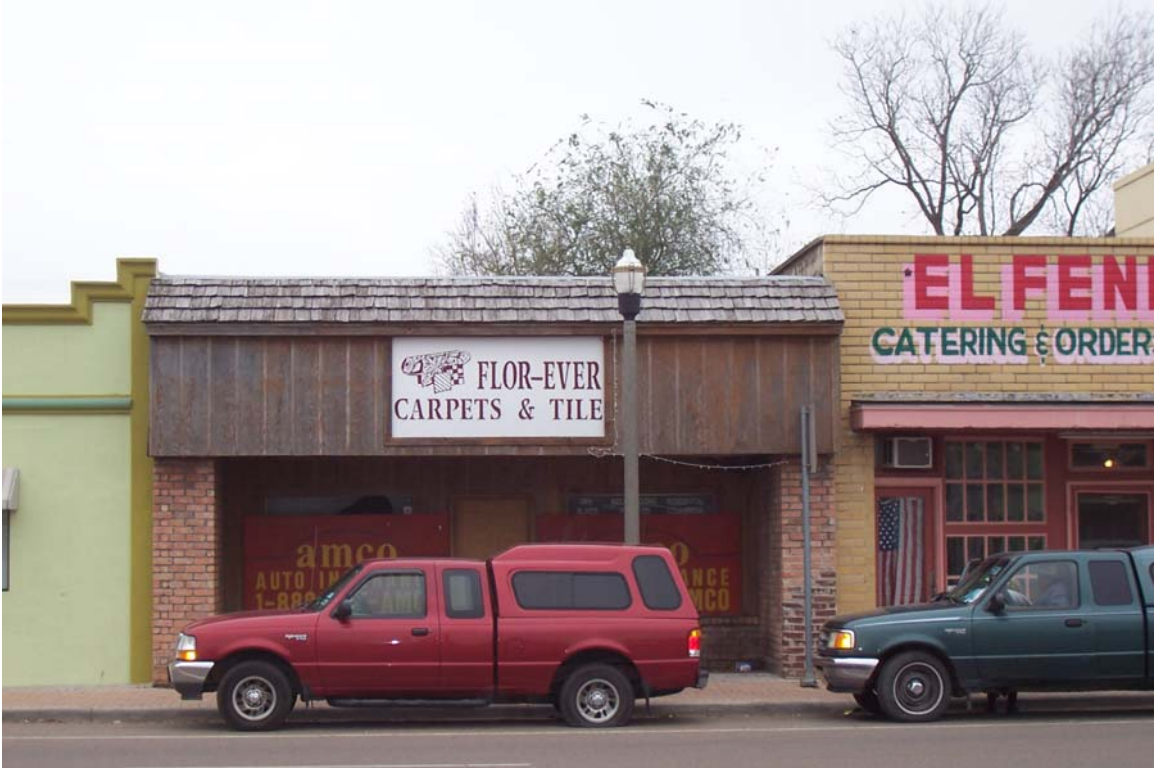
- Roof Poor  X  Fair \_\_\_\_\_ Good \_\_\_\_\_
- Interior Walls Poor  X  Fair \_\_\_\_\_ Good \_\_\_\_\_
- Exterior Walls Poor  X  Fair \_\_\_\_\_ Good \_\_\_\_\_
- Flooring Poor  X  Fair \_\_\_\_\_ Good \_\_\_\_\_
- Façade Poor  X  Fair \_\_\_\_\_ Good \_\_\_\_\_

Storefront description/dimensions:  Brown brick veneer with wood roof siding.

Property has 25 ln. ft. with 1 door and 2 windows.
