# Downtown Property Data

Property Number:	<u>42</u>	Property Owner:	<u>Sam Irby</u>
Property Address:	<u>335 N. Texas</u>	Primary Contact:	<u>-</u>
Mailing Address:	<u>-</u>	Phone Number:	<u>451-5919</u>
Lease Price:	<u>\$1 per sq ft</u>	Sale Price:	<u>-</u>
Lease Terms:	<u>1 year</u>	Square Feet:	<u>750</u>
Ceiling heights:	<u>8 ft</u>		
Floor material:	<u>Vinyl</u>		
Interior walls material:	<u>Sheetrock</u>		
Exterior building material:	<u>Stucco</u>		
Parking lot material:	<u>Asphalt</u>		
Number of parking spaces:	<u>12 plus</u>		
Number of building entrances/exits:	<u>1/1</u>

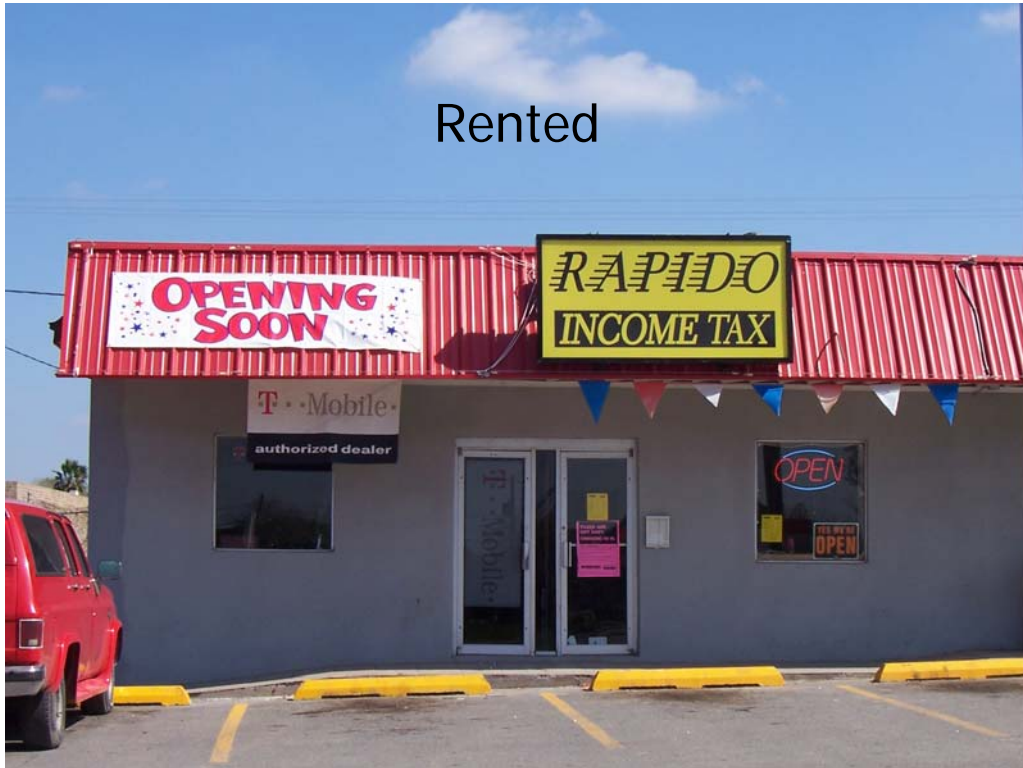
- Roof Poor  \_\_\_\_\_  Fair  \_\_\_\_\_  Good  X
- Interior Walls Poor  \_\_\_\_\_  Fair  X  Good  \_\_\_\_\_
- Exterior Walls Poor  \_\_\_\_\_  Fair  \_\_\_\_\_  Good  X
- Flooring Poor  \_\_\_\_\_  Fair  \_\_\_\_\_  Good  X
- Façade Poor  \_\_\_\_\_  Fair  X  Good  \_\_\_\_\_

Storefront description/dimensions:  Beige stucco veneer with beige aluminum   
 roof siding. Property has 1 door and 1 window.
