Downtown Property Data

Property Number:	<u>83</u>	Property Owner:	<u>Ruben Hinojosa</u>
Property Address:	<u>330 W. 4th St.</u>	Primary Contact:	<u>Mason & Co.</u>
Mailing Address:	<u>-</u>	Phone Number:	<u>423-4444</u>
Lease Price:	<u>-</u>	Sale Price:	<u>\$110,000</u>
Lease Terms:	<u>-</u>	Square Feet:	<u>2000</u>

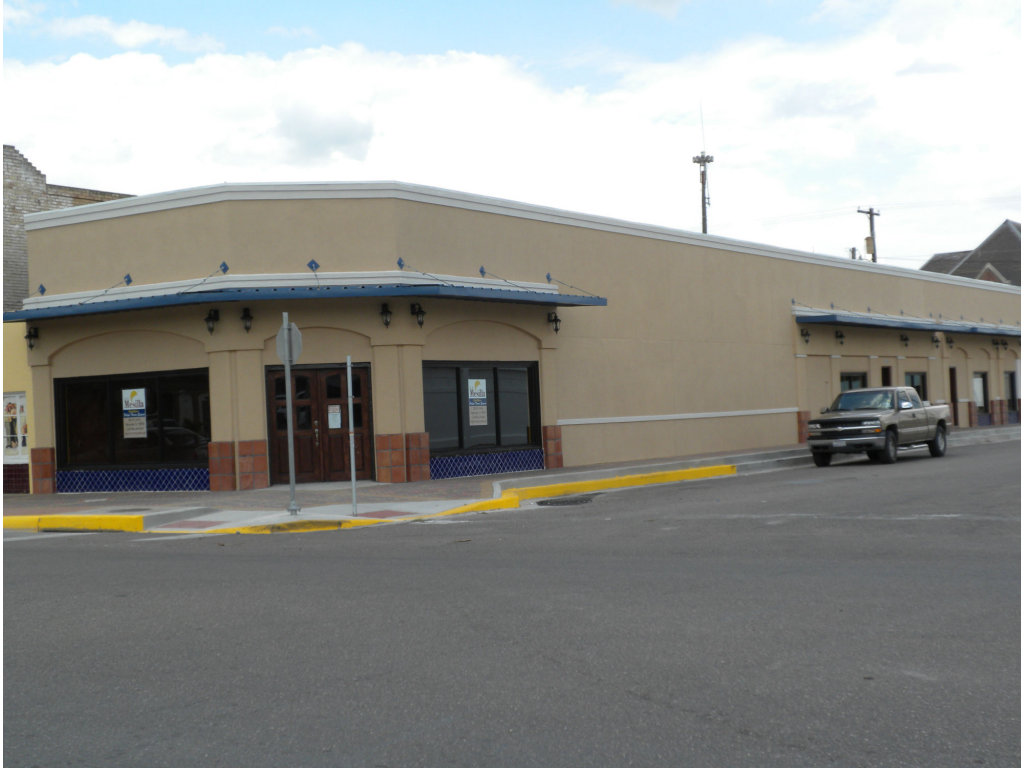
Storefront description/dimensions: Beige stucco veneer with wood roof shingles.

Property is on a corner lot and has 29 ln. ft. of storefront with 1 door and 4 _____ windows. _____
