Downtown Property Data

Property Number:	<u>44</u>	Property Owner:	<u>Sam Irby</u>
Property Address:	<u>335 N. Texas</u>	Primary Contact:	<u>-</u>
Mailing Address:	<u>-</u>	Phone Number:	<u>451-5919</u>
Lease Price:	<u>\$1 per sq ft</u>	Sale Price:	<u>-</u>
Lease Terms:	<u>1 year</u>	Square Feet:	<u>750</u>

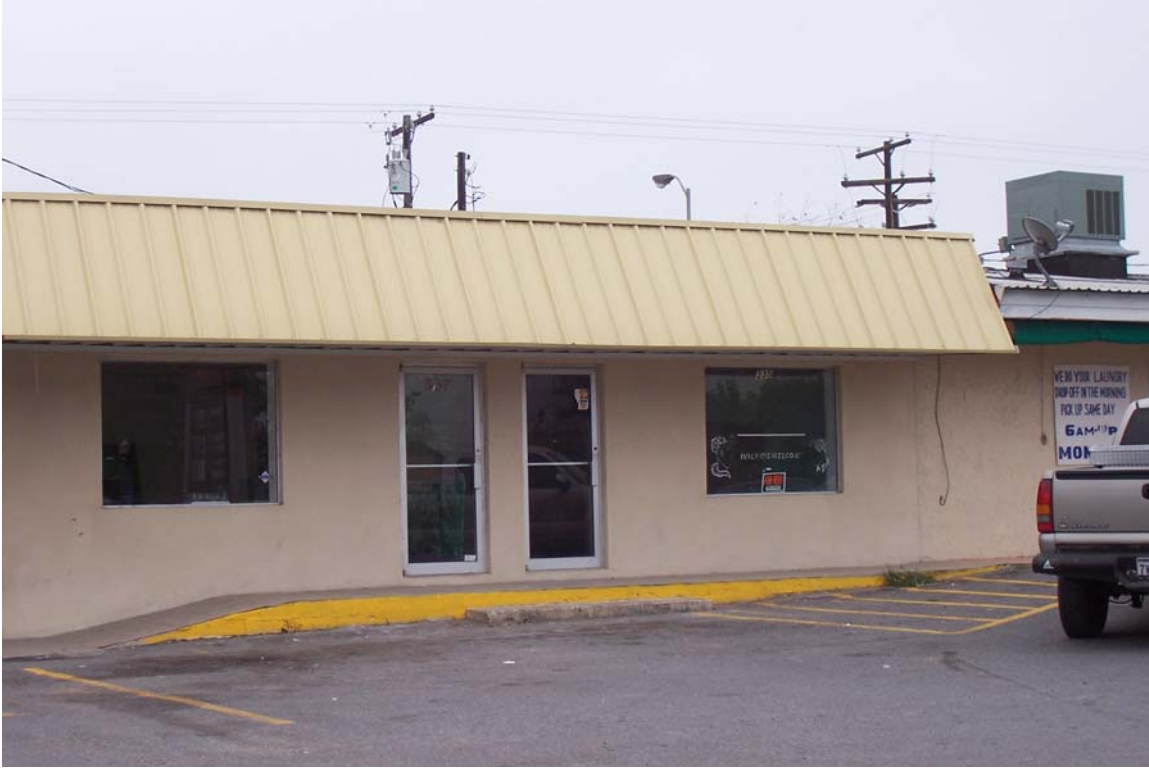
- Roof Poor _____ Fair _____ Good X
- Interior Walls Poor _____ Fair X Good _____
- Exterior Walls Poor _____ Fair _____ Good X
- Flooring Poor _____ Fair _____ Good X
- Façade Poor _____ Fair X Good _____

Storefront description/dimensions: Beige stucco veneer with beige aluminum roof siding. Property has 17 In. ft. of storefront with 1 door and 1 window.
